TPTL · Tripura Power Transmission Limited

AI TRANSMISSION TOWER INSPECTION & PROGRESS REPORT

High-Resolution Aerial Vision & Structural Defect Audit

Report ID: 36E7A6F502394EBD80CABA2A97A66871
Batch: BATCH-36E7A6F5
Period: 29 Sep 2025 – 29 Sep 2026 (1Y)

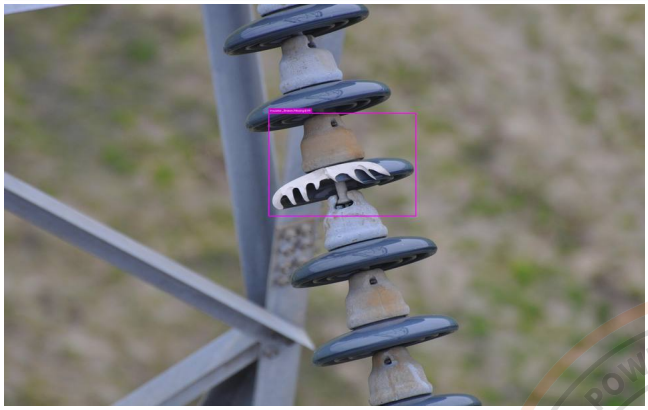
FINDING 1

Rust

AI analysis detected 1 rust/corrosion detection. 1 detection is classified as critical. Highest detection confidence: 65.6%. Prompt inspection and appropriate corrective action are recommended.

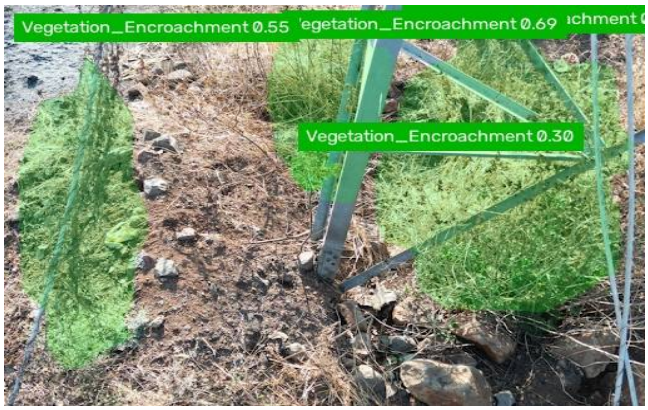
FINDING 1

Veg

AI analysis detected 4 vegetation detections. 4 detections are classified as critical. Highest detection confidence: 80.2%. Prompt inspection and appropriate corrective action are recommended.

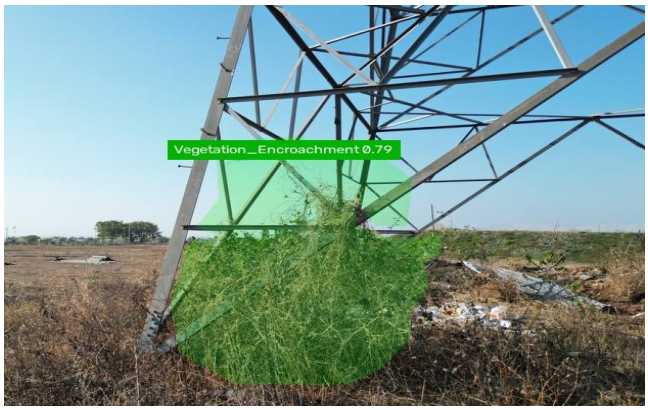
No. 0015 Critical

Veg

AI analysis detected 1 vegetation detection. 1 detection is classified as critical. Highest detection confidence: 79.2%. Prompt inspection and appropriate corrective action are recommended.

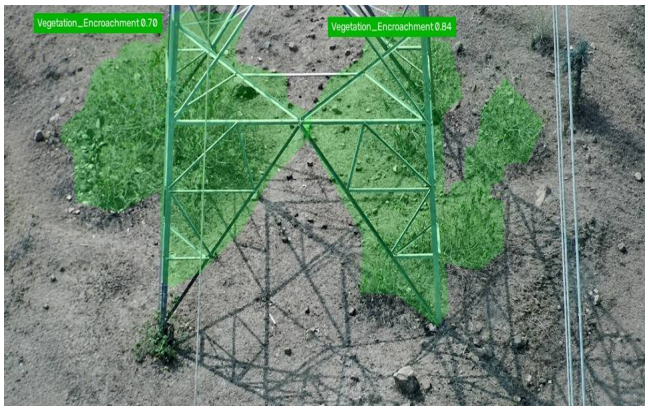
No. 0018 Critical

Veg

AI analysis detected 2 vegetation detections. 2 detections are classified as critical. Highest detection confidence: 84.2%. Prompt inspection and appropriate corrective action are recommended.
